MICHIGAN BOARD OF BOILER RULES

September 16, 2008

*** A G E N D A ***

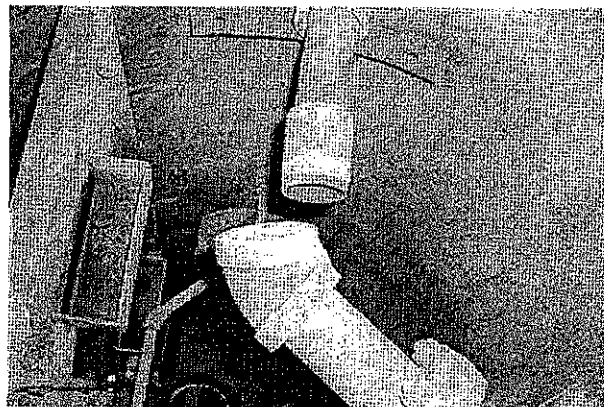
Inspections of crossover steam drum and the mud drum found extremely good cleanliness, down to base metal. The feedwater line in the steam drum had become dislodged, this was repaired, with no apparent internal damage to tubes or excessive accumulations.

Boiler #3 maintains a greater magnetite (black iron oxide) layer than the high-pressure boilers. I continue to note red iron oxide in the feedwater steam drum particularly along the feedwater tray. This suggests some oxygen intrusion (possibly during storage) however extensive pitting was not observed. Internal cleanliness was considered quite acceptable. Again, no evidence of O₂ corrosion was apparent in the crossover steam drum and mud drum. Water levels at the main steam drum were at appropriate 50% level, however levels in the crossover steam drum were noticeably higher....slightly above the manhole cover. This has been observed in the past. *Recommend reviewing original specifications for proper control of water levels.*
